Effect of FRCM Repair on the Bond Behavior of Corroded Reinforced Concrete
Beams Subjected to Static and Cyclic Loading

A THESIS
SUBMITTED TO THE FACULTY OF
UNIVERSITY OF MINNESOTA
BY

IN PARTIAL FULFILLMENT OF THE REQUIREMENTS
FOR THE DEGREE OF
MASTER OF SCIENCE

August 2017

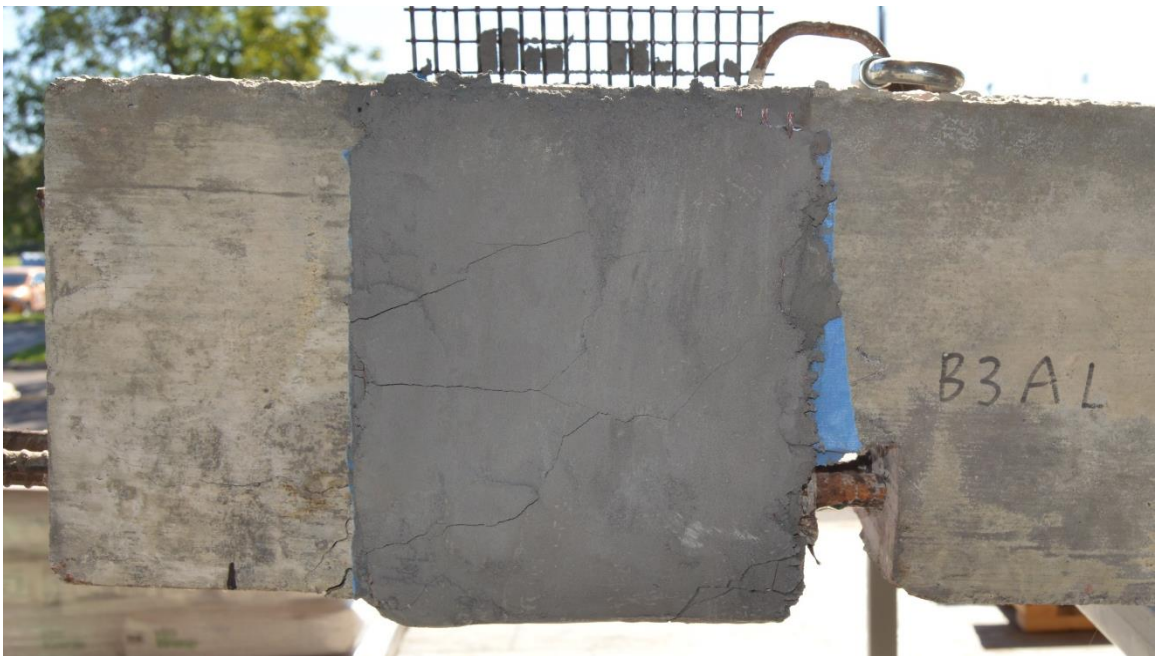
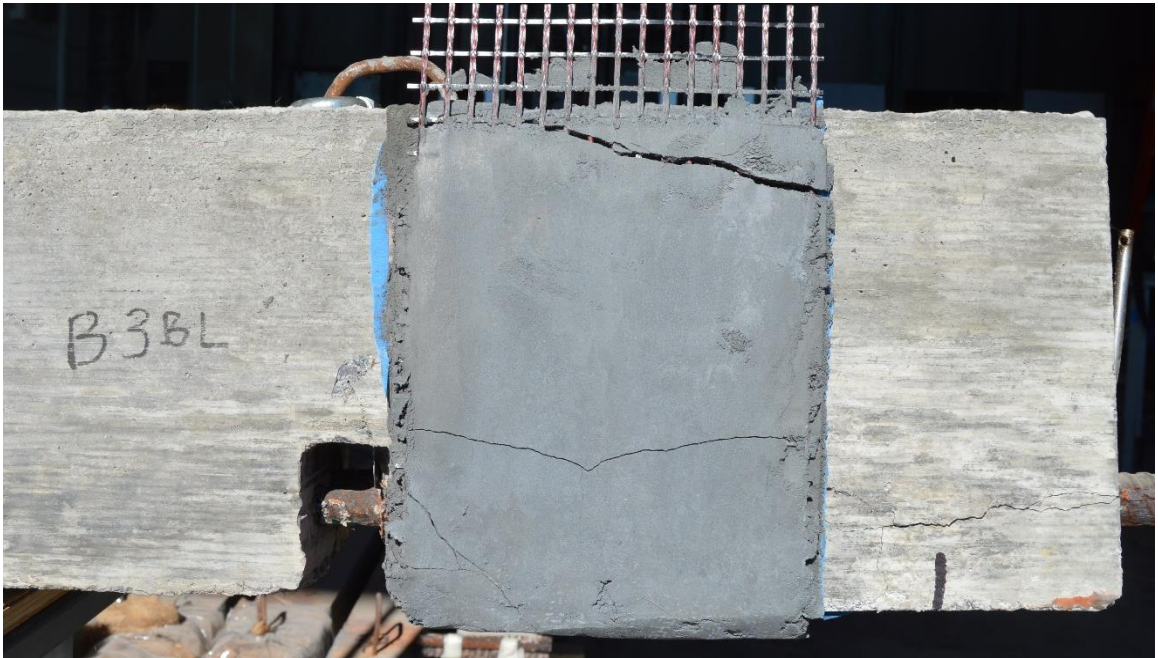
Beam H-R1-F-1 was fatigued using a load range of 12.83 kips. The beam failed at 3695 cycles. At the start of the test, a flexural crack formed at the right of midspan. During the test, a second crack developed beneath the left loading point. This crack was more diagonal indicating that it was likely due to shear instead of flexure. Near the left support, cracks occurred beneath the repair, which showed through the repair. The repair effectively held the concrete cover below the bars forcing a pullout bond failure to occur instead of a splitting bond failure. After removal of the bars, it was found that the concrete lugs were sheared off, which confirms the pullout bond failure (Figure G.3). The repair near the right support showed some cracking, but no indication of failure.

Figure G.1: Failure at left support of Beam H-R1-F-1 (Side A)

Figure G.2: Failure at left support of Beam H-R1-F-1 (Side B)

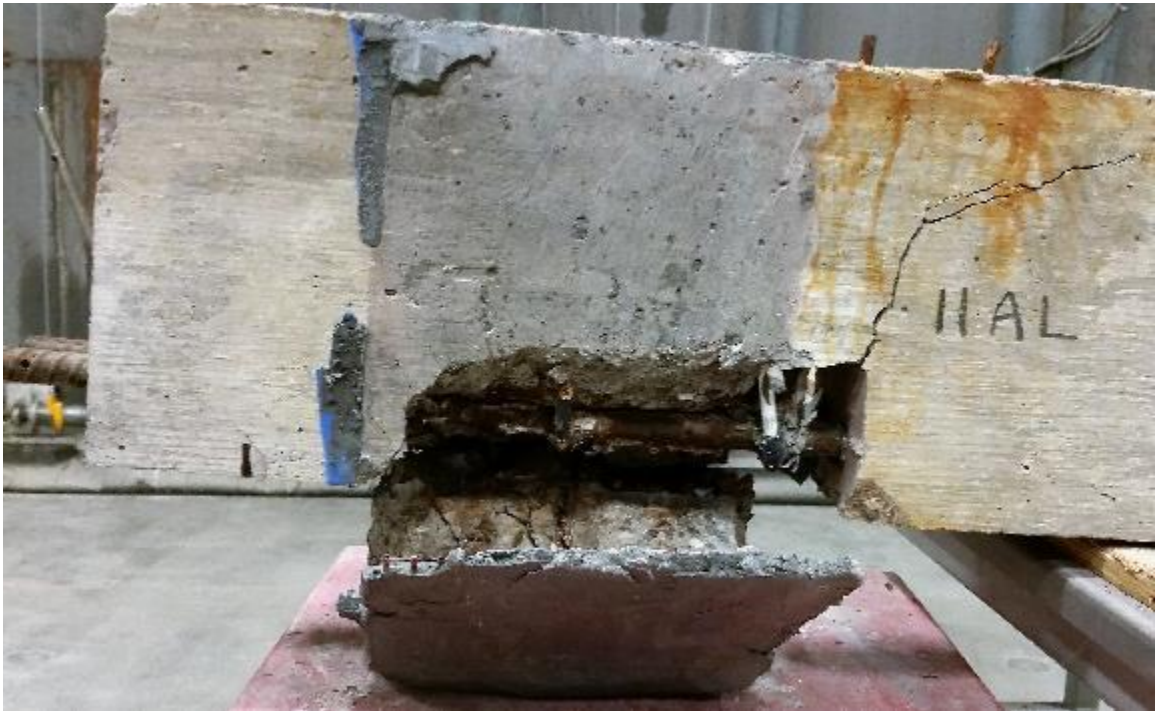
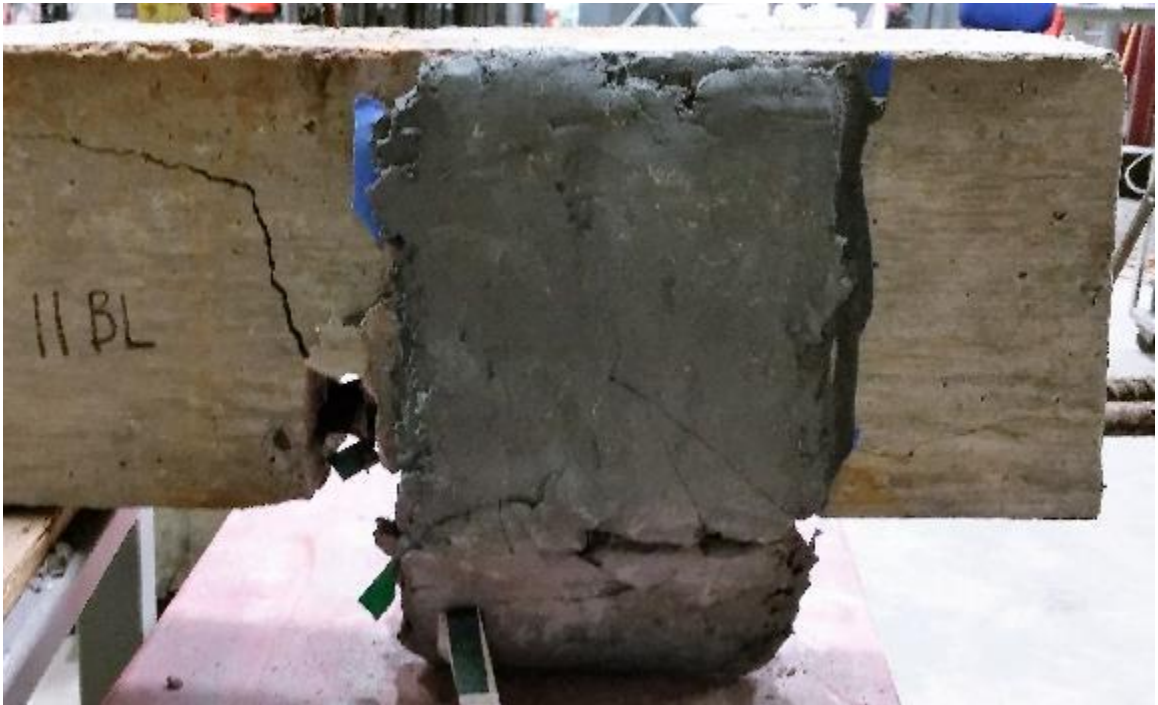
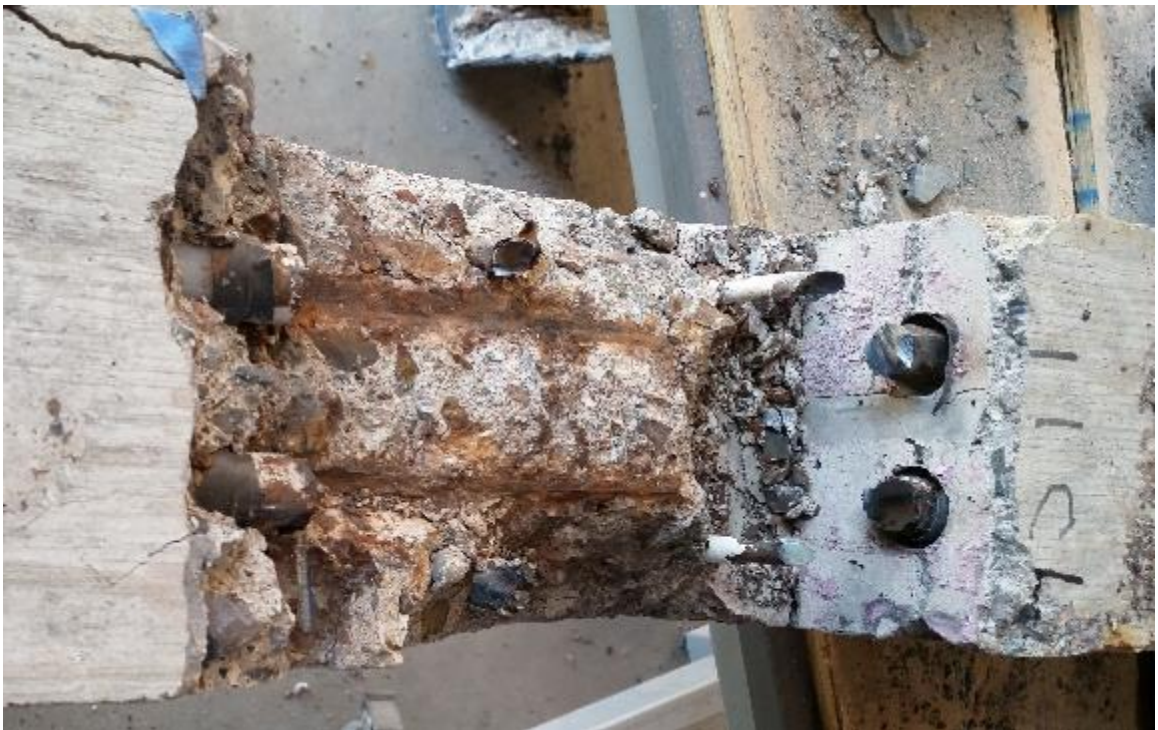
At the start of the test, a flexural crack formed to the right of midspan. A shear crack originating at the corner of the pocket near the left support formed during the test. The cracks did not show through the mortar. Towards the end of the test the repair lost bond with the surface and popped off. Without the confining pressure of the repair, the bars slipped and failed the beam. At the time of failure, the flexural crack near midspan caused some concrete crushing of the compression zone.

Figure G.4: Failure at right support of Beam H-R1-F-2 (Side A)

Figure G.5: Failure at right support of Beam H-R1-F-2 (Side B)

Figure G.6: Beam H-R1-F-2 concrete keys. Top is Side A and bottom is Side B.

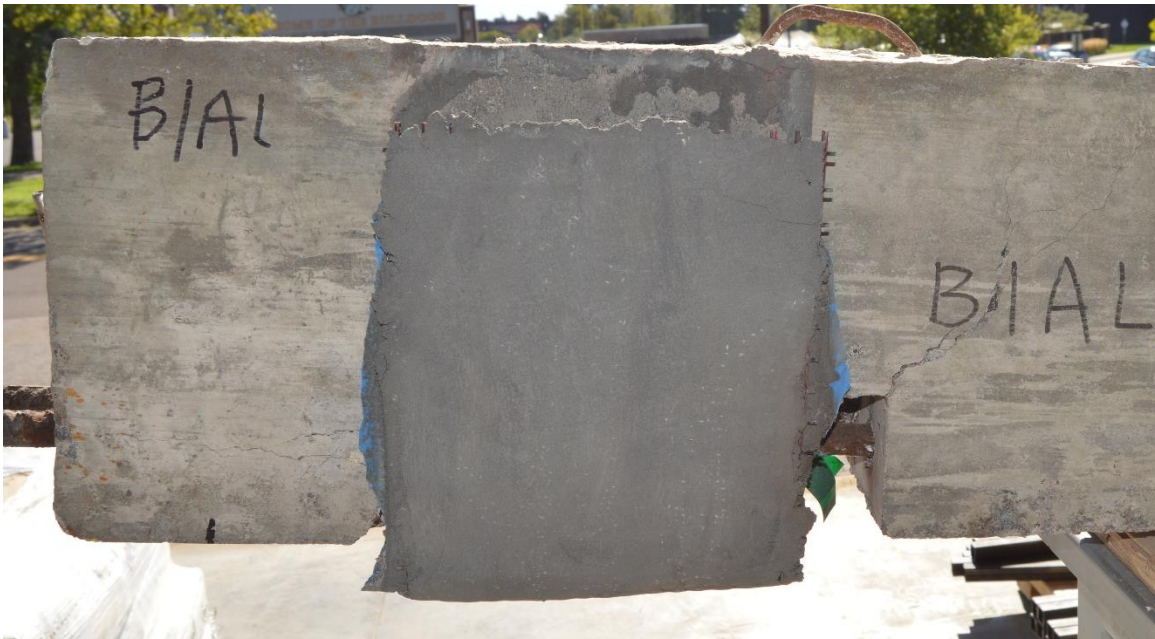
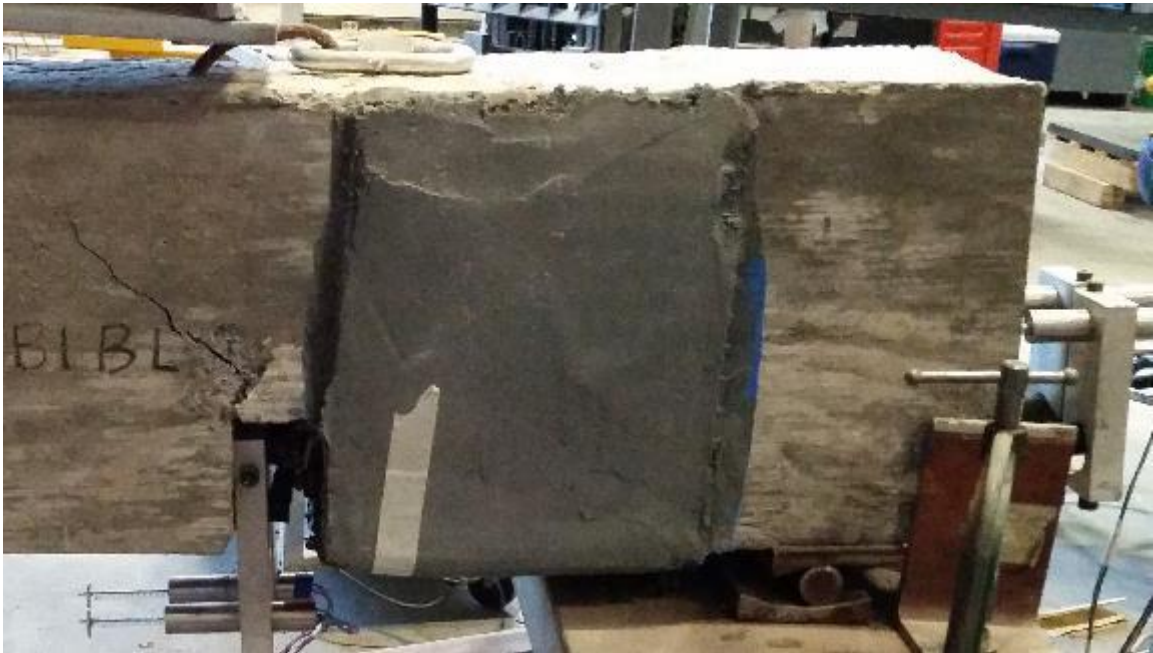
Beam H-R1-F-3 was fatigued using a load range of 12.33 kips. The beam failed at 149,407 cycles. At the start of the test, a flexural crack formed at the left of midspan. During the test, a second flexural crack developed beneath the right loading point. The failure occurred at the left support. The repair was pushed away from the beam on both sides from the force of the shear crack. The bond of the repair to the concrete surface failed, which allowed the concrete cover to be released at the bottom of the beam. This caused the bond between the reinforcement and the concrete to suffer and lead to bar slip. The data shows that the initial slip of the bars at the left end occurred at 40% of the fatigue life. The repair allowed the beam to continue to be loaded after initial bar slip.

Figure G.7: Failure at right support of Beam H-R1-F-3 (Side A)

Figure G.8: Failure at right support of Beam H-R1-F-3 (Side B)

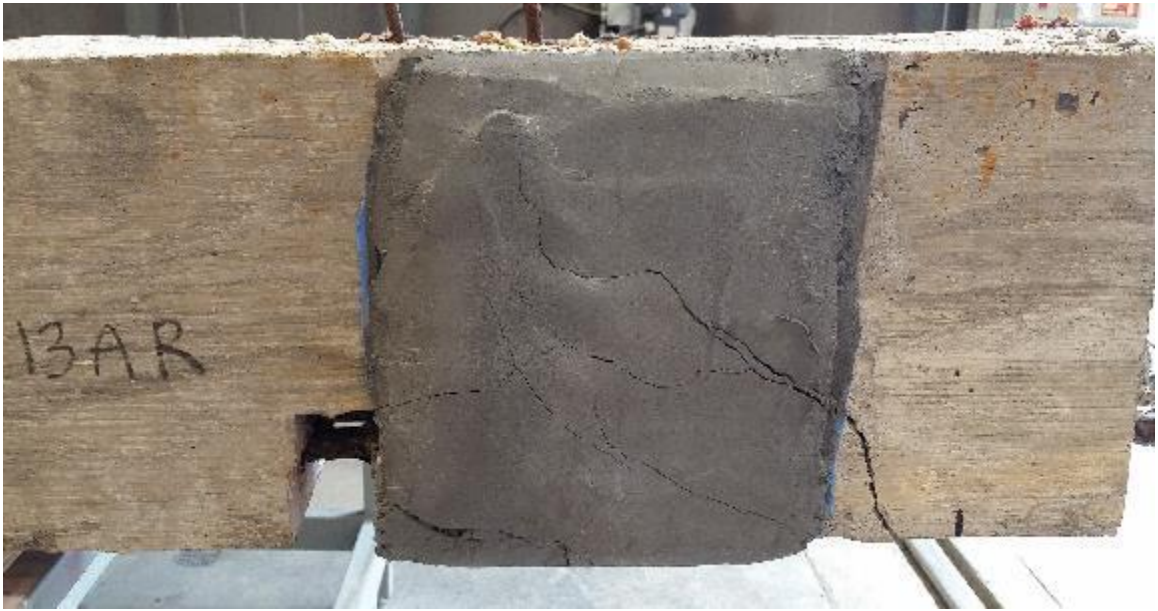
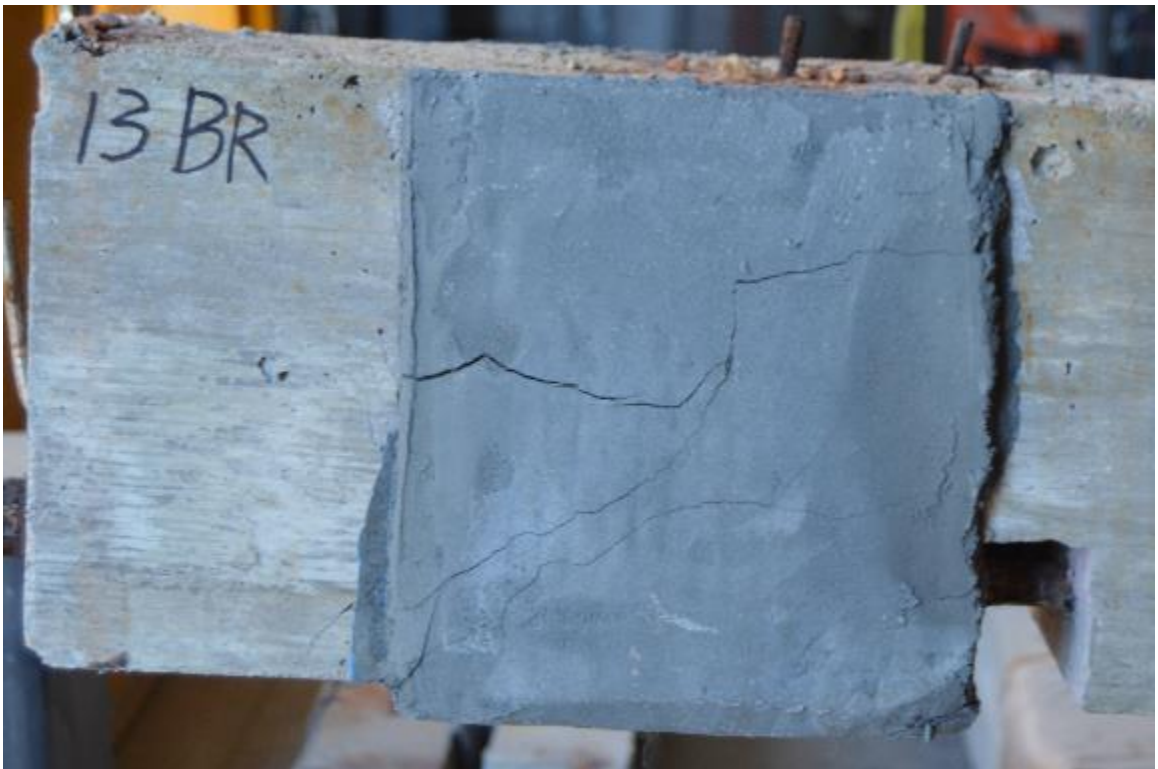
Beam H-R1-F-4 was fatigued using a load range of 11.83 kips and failed at 55,109 cycles. At the start of the test, a flexural crack formed to the right of midspan. During the test several shear cracks formed at the right support and showed through the repair. The repair remained bonded to the concrete surface throughout the test. The confinement applied from the repair forced the beam to exhibit a pullout bond failure at the right support. The bar slip at the right end increased slowly throughout the test and increased sharply at failure. No failure occurred at the left support.

Figure G.9: Failure at right support of Beam H-R1-F-4 (Side A)

Figure G.10: Failure at right support of Beam H-R1-F-4 (Side B)

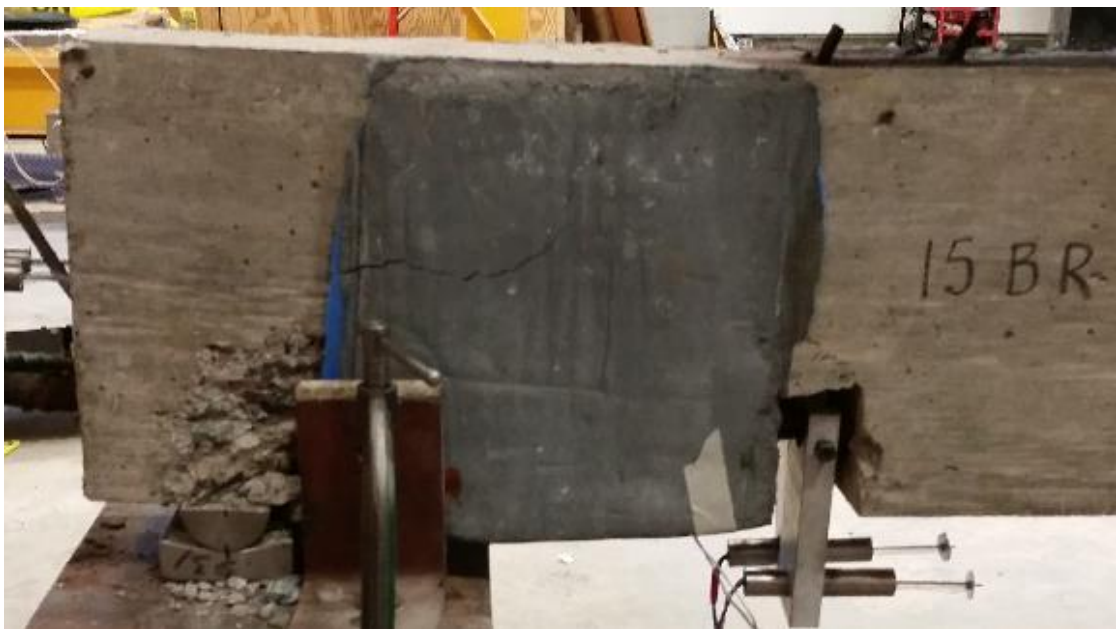
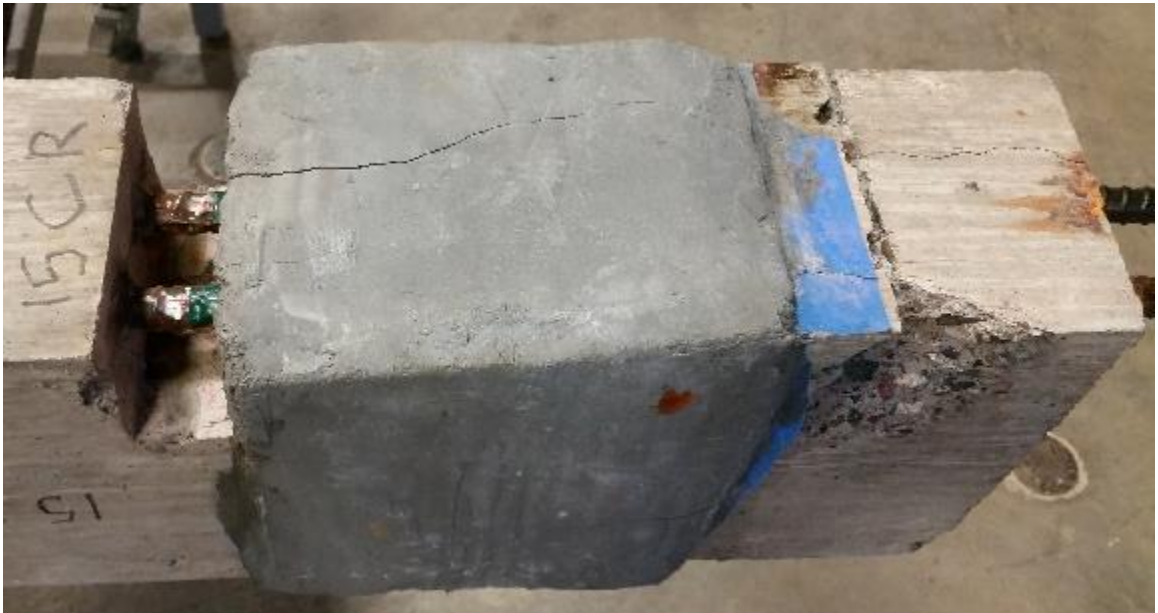
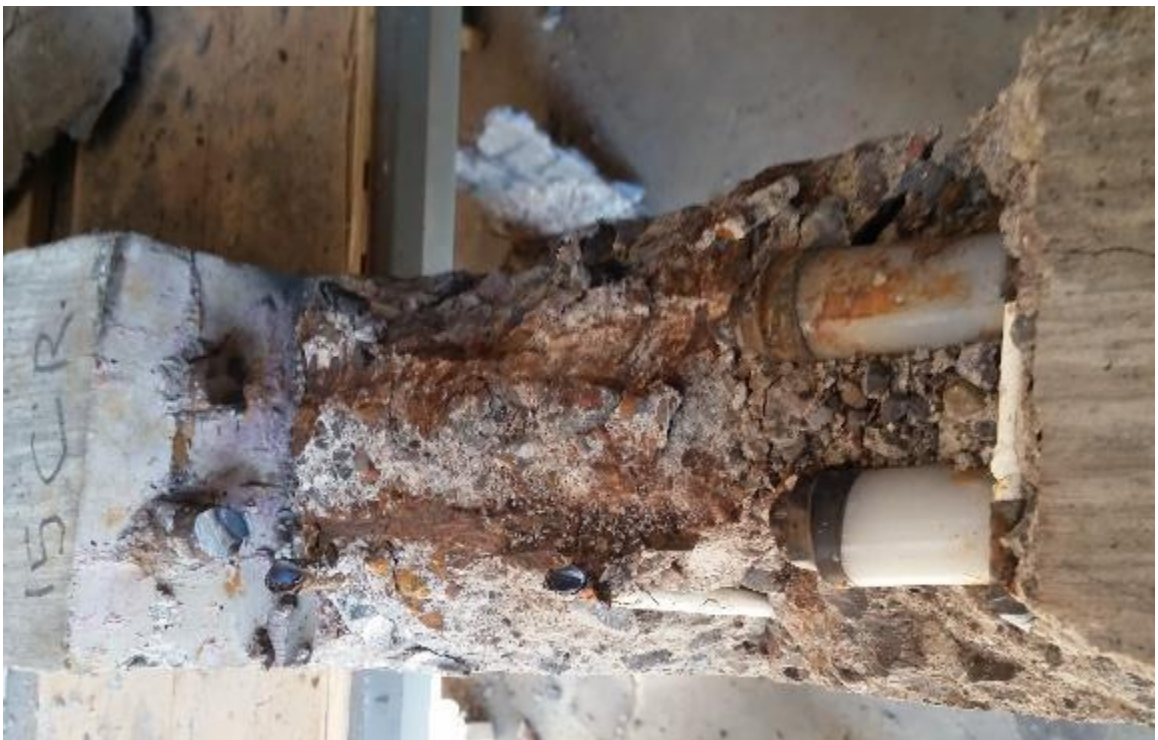
Figure G.14: Failure at right support of Beam H-R1-F-5 (Side B)

Figure G.15: Failure at right support of Beam H-R1-F-5 (Side C)

Figure G.16: Beam H-R1-F-5 concrete keys. Top is Side A and bottom is Side B.

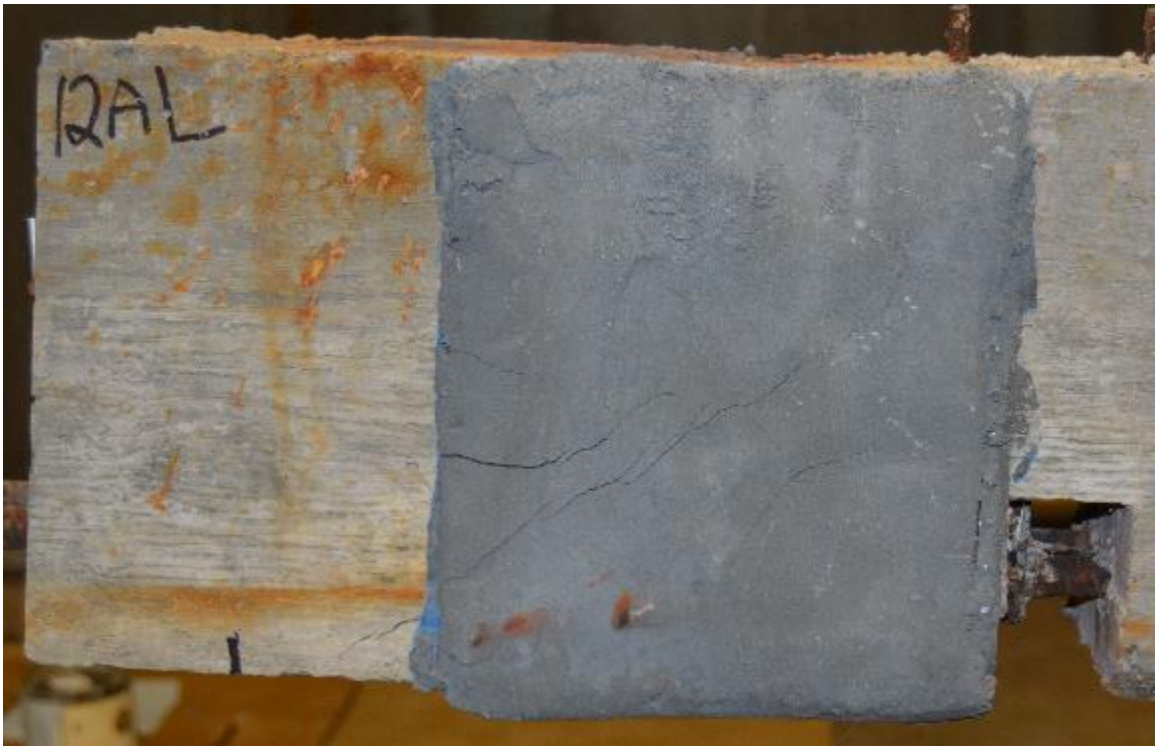
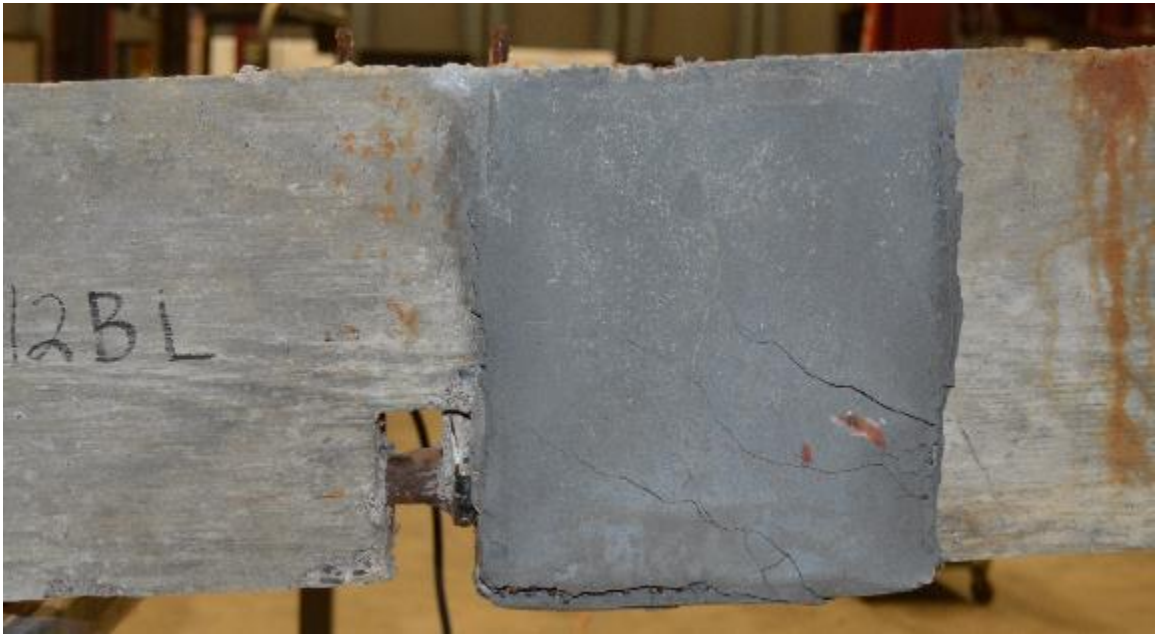
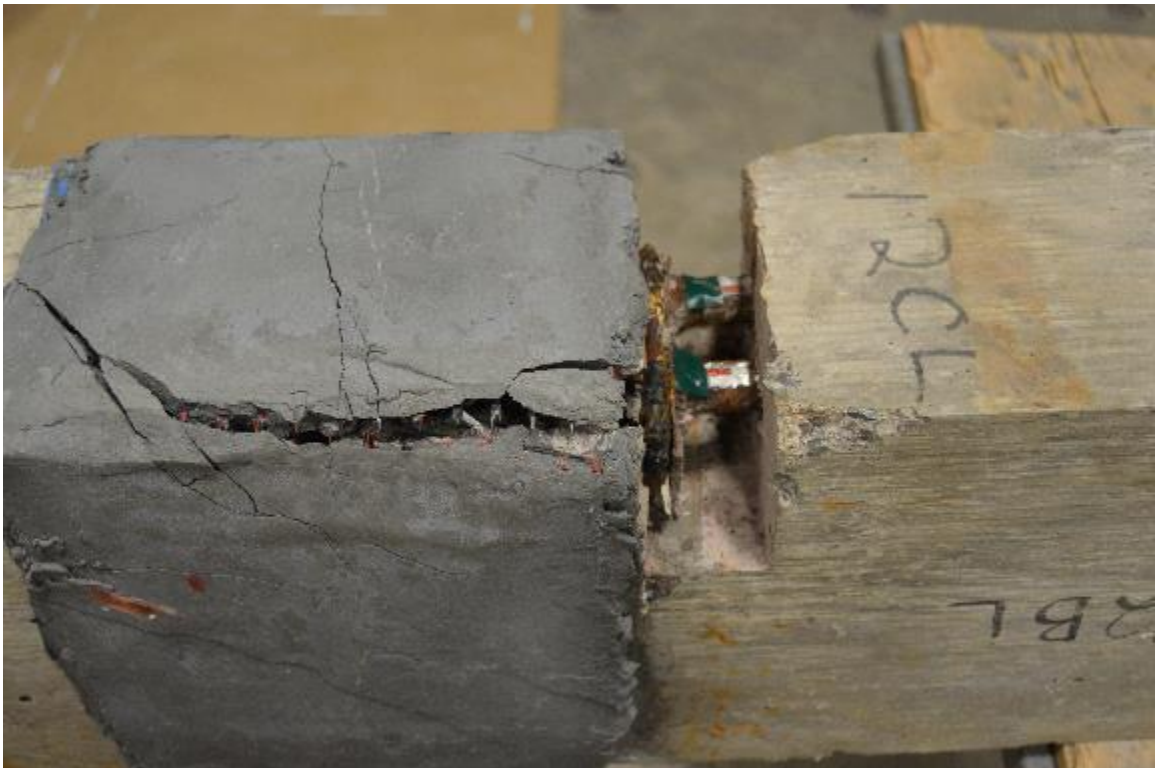
Beam H-R1-F-6 was fatigued using a load range of 11.58 kips and beam failed at 29,223 cycles. At the start of the test, a flexural crack formed to the left of midspan. During the test, shear cracks began to form near both supports that propagated through the repair. As the cracks grew, the repair was effective in holding the concrete cover and extending the life of the beam. The bond of the repair to the concrete remained intact throughout the duration of the test. A pullout bond failure at the left support caused the beam to fail. A small level of bar slip occurred near the right support, but the bar slip at the left support was more significant. There was an issue with the data recording during this test, so there are no data results.

Figure G.17: Failure at left support of Beam H-R1-F-6 (Side A)

Figure G.18: Failure at left support of Beam H-R1-F-6 (Side B)

Figure G.19: Failure at left support of Beam H-R1-F-6 (Side C)

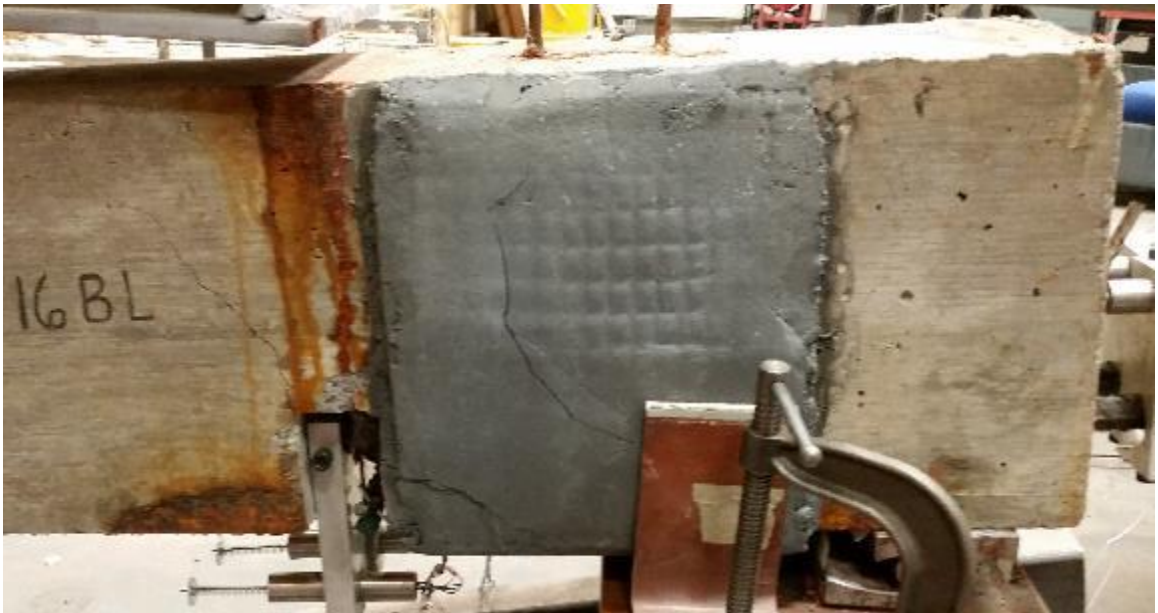
Figure G.22: Failure at left support of Beam H-R1-F-7 (Side B)

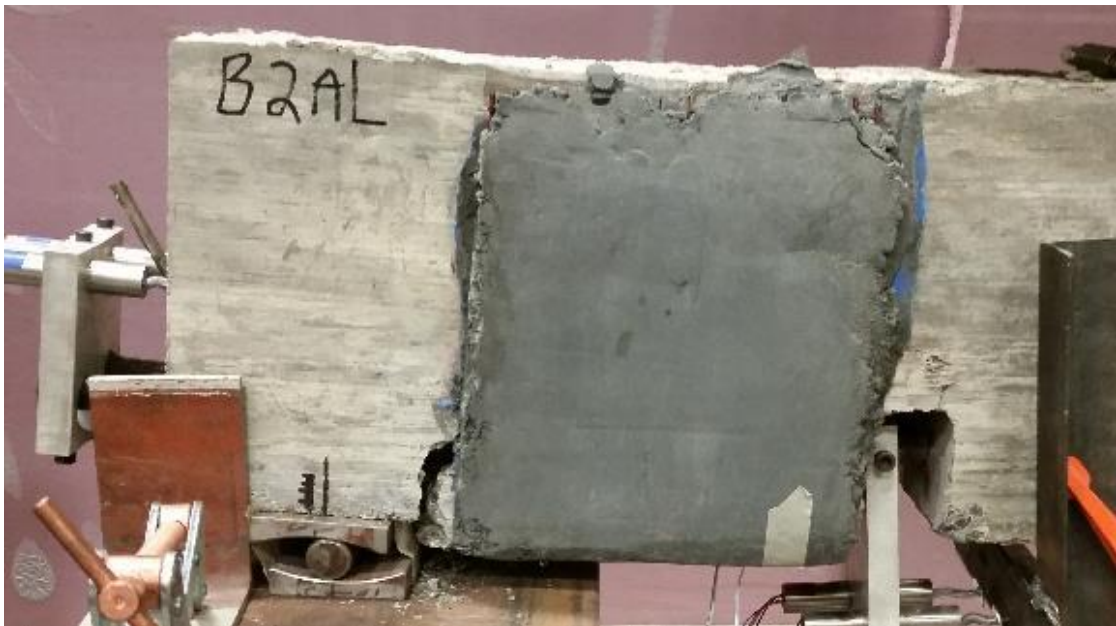
Figure G.24: Failure at left support of Beam H-R1-F-8 (Side A)

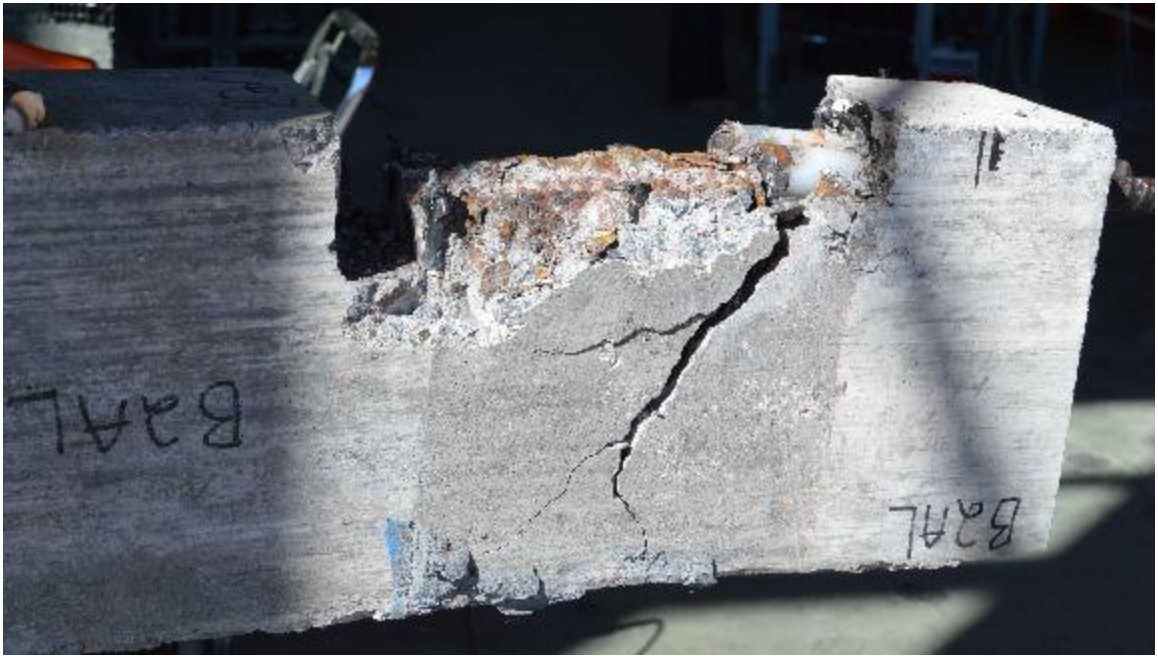
Figure G.26: Failure at left support of Beam H-R1-F-8 with repair removed (Side A)

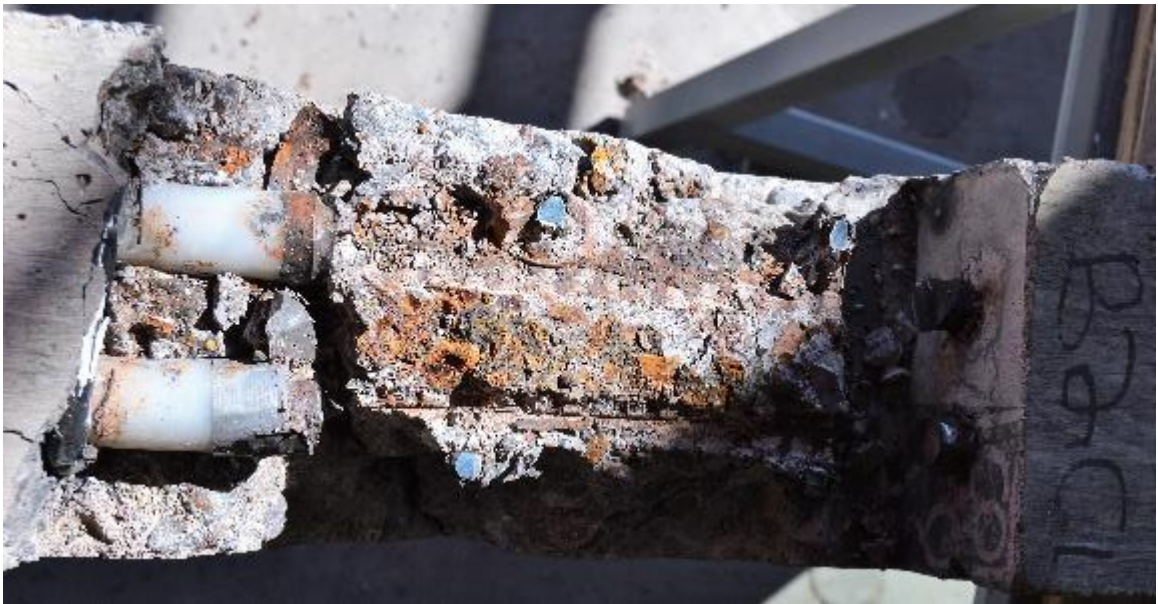
Figure G.27: Beam M-R1-F-1 concrete keys. Top is Side B and bottom is Side A.

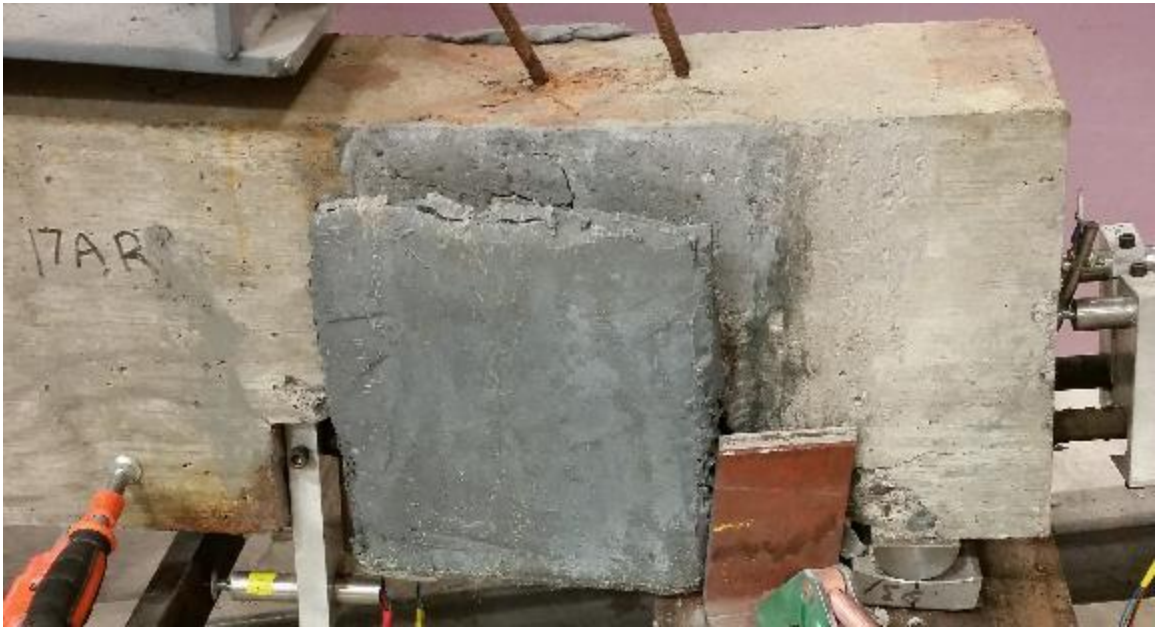
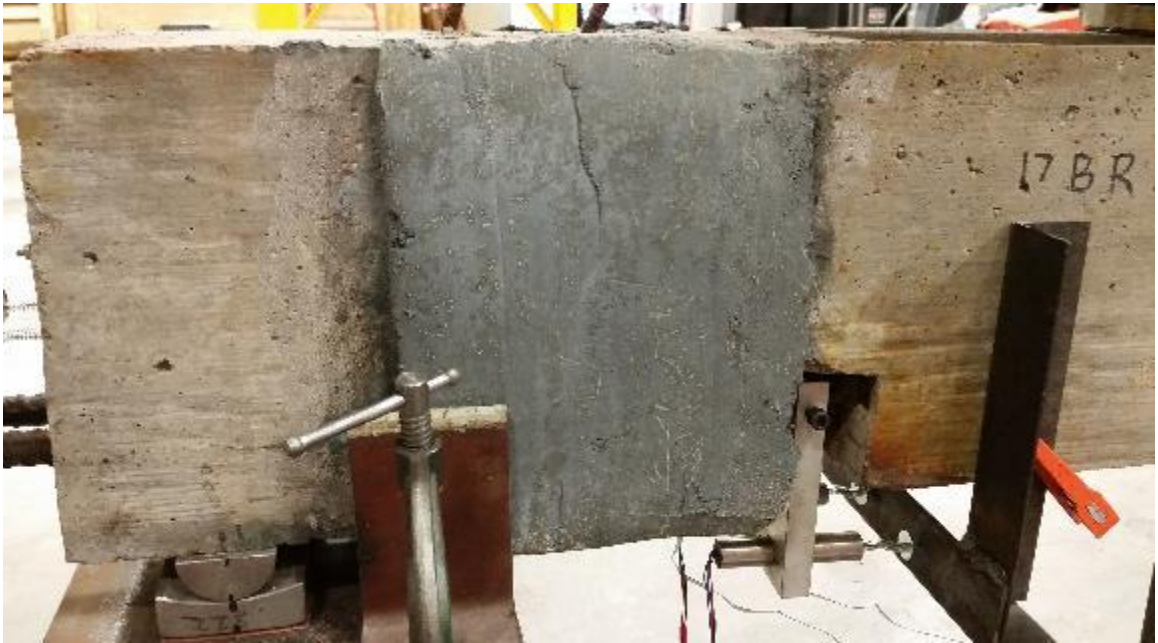
Figure G.31: Failure at left support of Beam H-R2-F-1 (Side A)

Figure G.32: Failure at left support of Beam H-R2-F-1 (Side B)

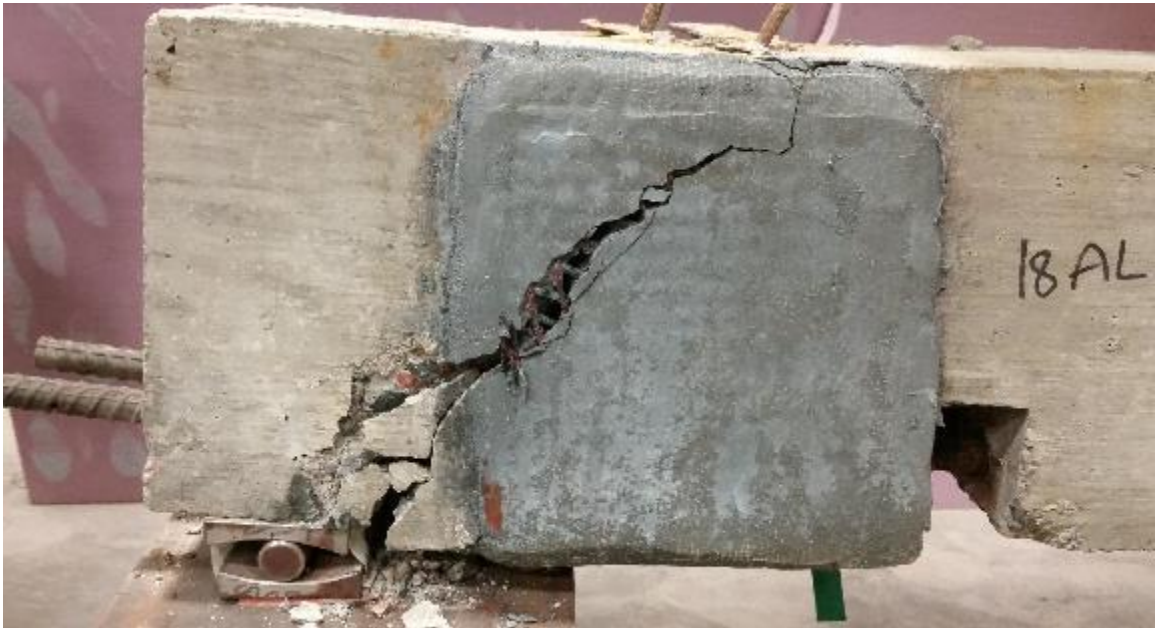
Figure G.35: Failure at left support of Beam H-R2-F-2 (Side A)

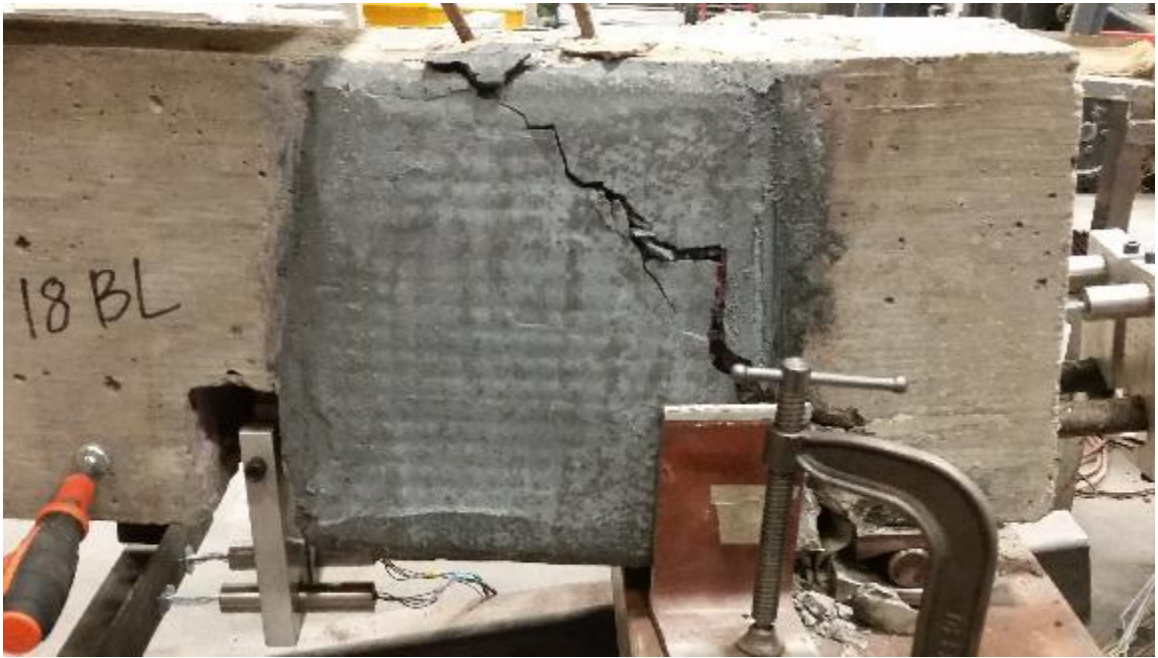
Figure G.37: Failure at left support of Beam H-R2-F-2 (Side B)

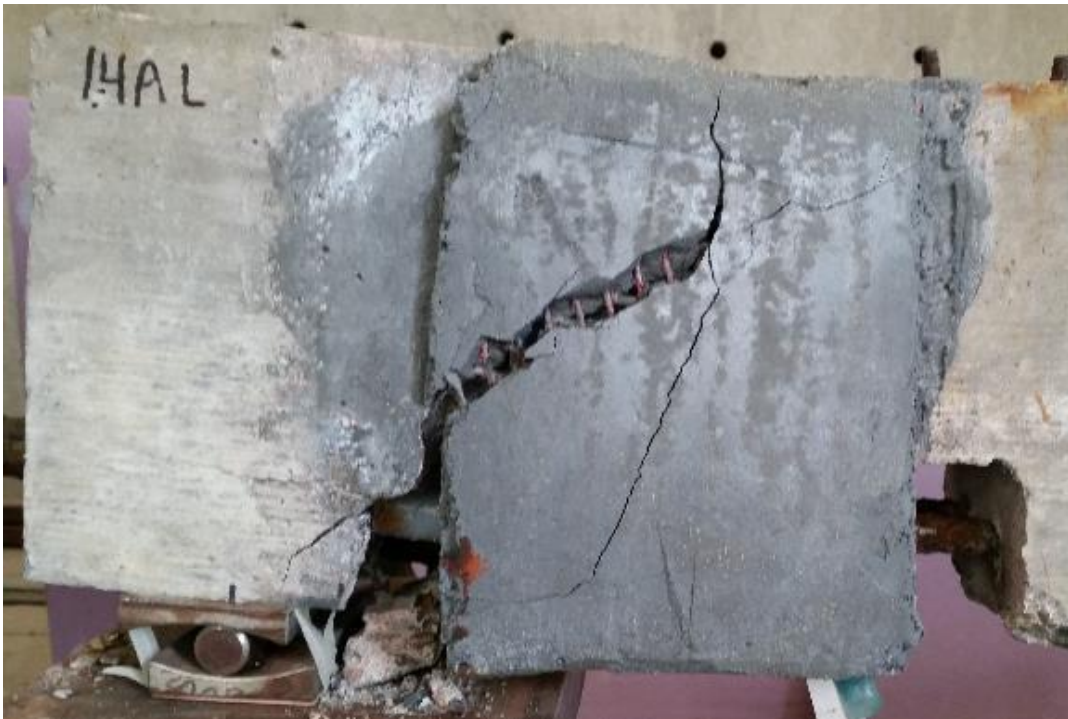
Figure G.44: Failure at left support of Beam H-R2-F-4 (Side A)

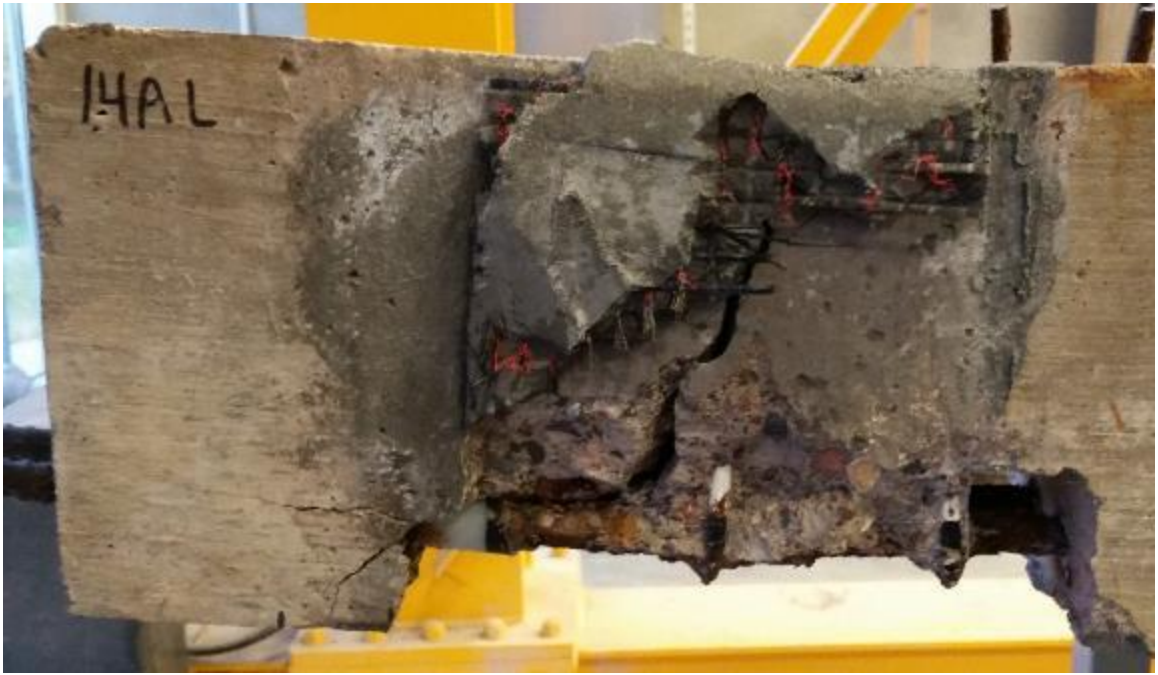
Figure G.45: Repair removed at left support of Beam H-R2-F-4 (Side A)
